**RISK ASSESSMENT OF SELECTED TREES  
FOR RISK**

**ALONG  
WOODMONT BEACH DRIVE SOUTH**

**Revised July 7, 2017**

**John Blackburn**

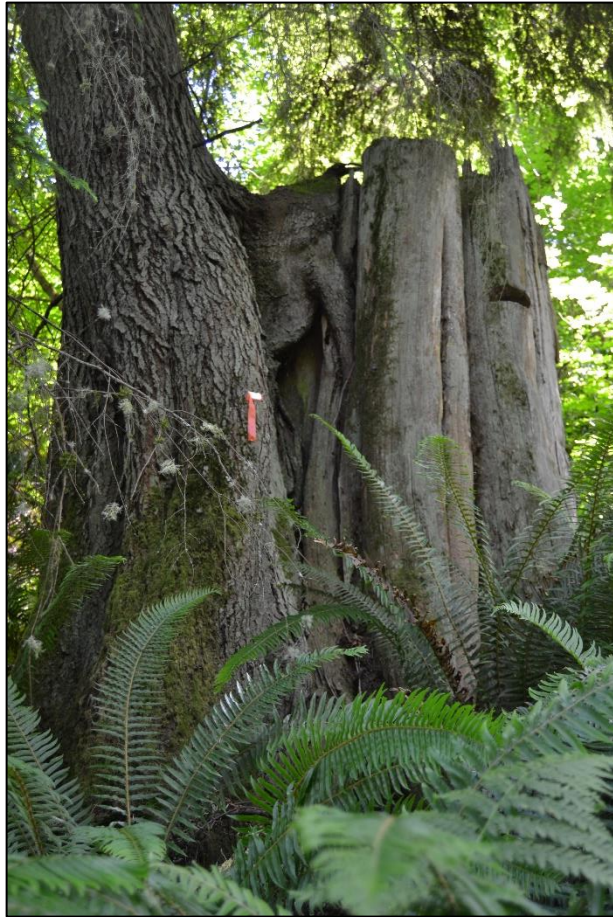
Photo # 1: Showing an aluminum numbered tag and short piece of survey tape stapled to it.

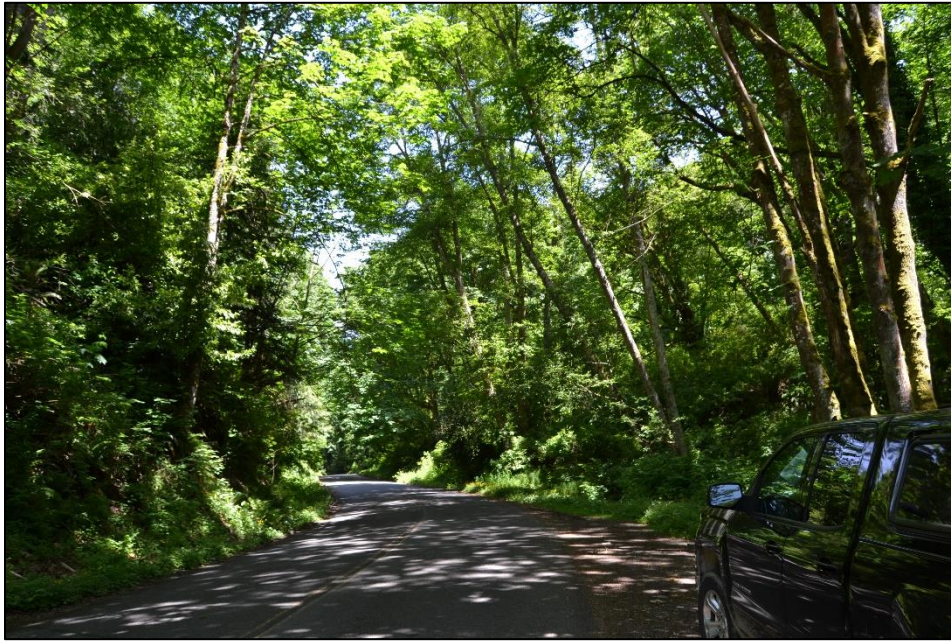
**Photo # 2:** A typical photo of the forest on both sides of the road. Trees leaning to capture sunlight. Dense underbrush. English Ivy infestation.

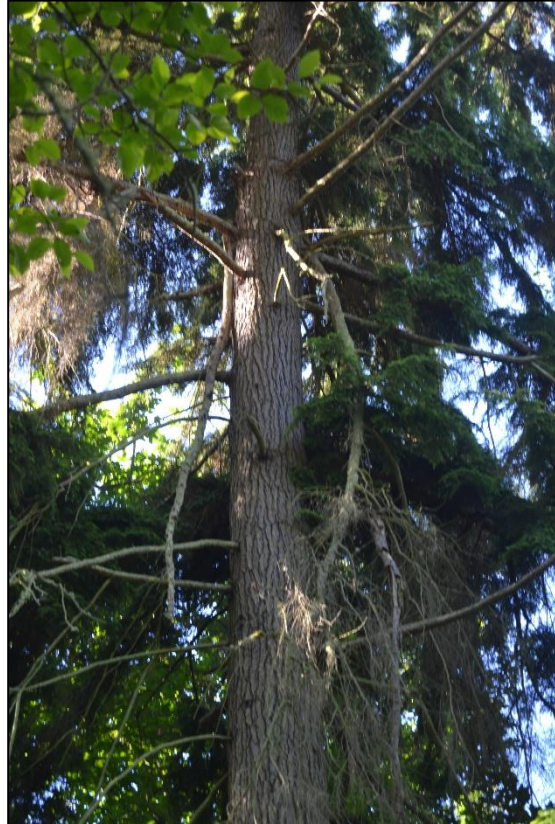
Photo # 3: Example of dead and broken branches in a tree that have the potential to fail and injure someone, damage property, or disrupt the use of the road.

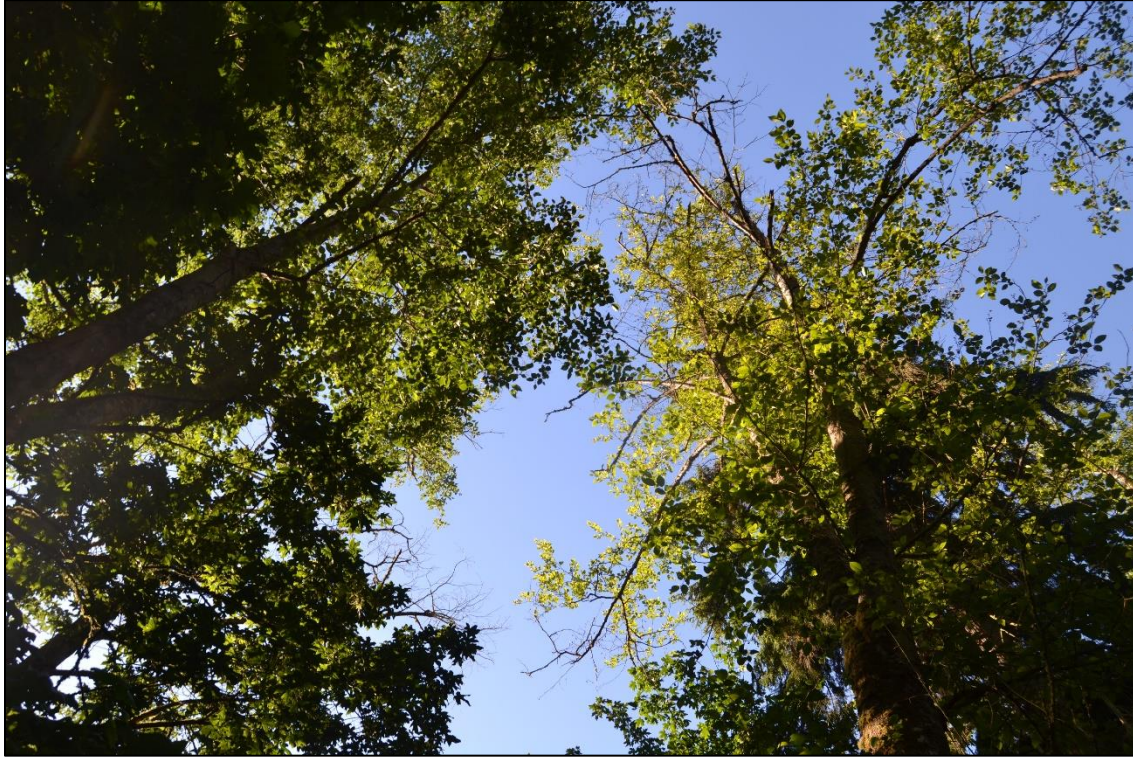
Photo # 3: Example of a large tree with dead branches in the canopy. In some cases removal of the dead branches is all that is necessary. In other trees, if there is extensive decay, the tree may need to be converted to a Habitat Tree, Nurse Log, and a Brush Pile.
